DEPARTMENT OF TRANSPORTATION

Quality Assurance and Source Inspection

Contract #: 04-0120F4Cty: SF/ALA Rte: 80 PM: 13.2/13.9File #: 82.28**WELDING INSPECTION REPORT****Resident Engineer:** Siegenthaler, Peter**Address:** 333 Burma Road**City:** Oakland, CA 94607**Report No:** WIR-017223**Date Inspected:** 23-Sep-2010**Project Name:** SAS Superstructure**OSM Arrival Time:** 500**Prime Contractor:** American Bridge/Fluor Enterprises, a JV**OSM Departure Time:** 1330**Contractor:** Westmont Industries**Location:** Santa Fe Springs, CA.**CWI Name:** R. Rodriguez, R. Dominguez**CWI Present:** Yes No**Inspected CWI report:** Yes No N/A**Rod Oven in Use:** Yes No N/A**Electrode to specification:** Yes No N/A**Weld Procedures Followed:** Yes No N/A**Qualified Welders:** Yes No N/A**Verified Joint Fit-up:** Yes No N/A**Approved Drawings:** Yes No N/A**Approved WPS:** Yes No N/A**Delayed / Cancelled:** Yes No N/A**Bridge No:** 34-0006**Component:** Travelers**Summary of Items Observed:**

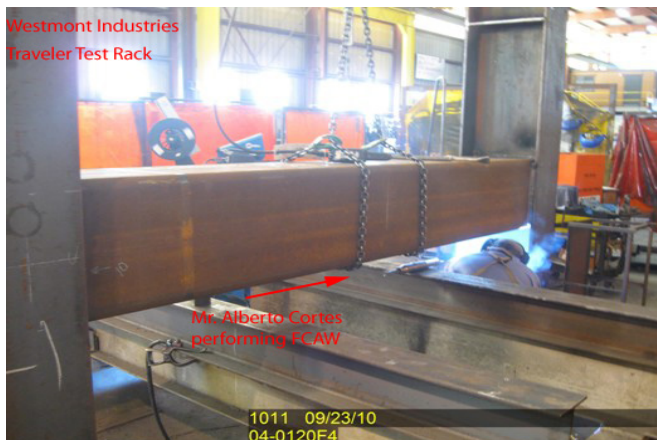
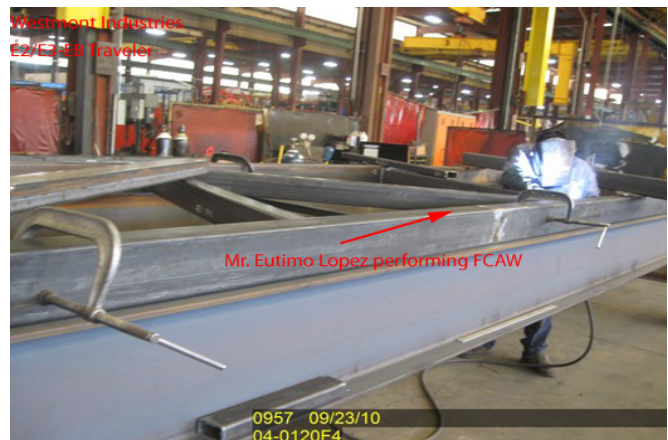
See attached pictures below.

On this date, the QA Inspector observed Westmont Industries (WMI), production welder Larry Swanson, continuing to perform Flux Core Arc Welding (FCAW) fitting, tacking and grinding activities for the Traveler Frames. The QA Inspector observed that Mr. Swanson continued to perform these activities on the backing bars, which will be utilized for the Complete Joint Penetration (CJP) Traveler Frame splices, identified as A240 and B240, reference drawing # WMI-SAS-240.

The QA Inspector observed Mr. Swanson continue to cut and bevel 4 each pieces of backing bar material. After the material was cut and beveled, the QA Inspector observed the pieces of material being placed or fit into the end of the TS material. After the pieces were fit, the QA Inspector then observed Mr. Swanson FCAW tack weld the 4 pieces of material and then remove the tack welded backing bar. The QA Inspector then observed Mr. Swanson FCAW the 4 each ends of the backing bar. After the FCAW was complete, the QA Inspector then observed Mr. Swanson grind flush the 4 each welds and then contour or "round off" the corners of the backing bar.

The QA Inspector observed the grinding continued until the completed backing bar, achieved a tight fit on the interior of the TS end. The QA Inspector observed that the backing bar material being utilized was A572 Gr. 50 and listed in the same group as the base metal, per the applicable Welding Procedure Specification (WPS) requirements.
